M-PA 101

Part #5: *Understanding and Using Firmware*

By Mark Cobbeldick, KB4CVN **2014-12-02**

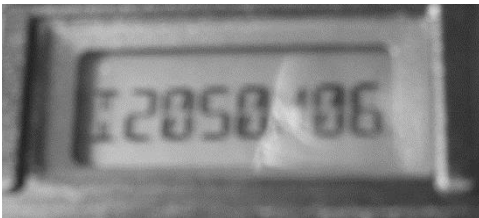
I2050M06

- 20 = CONVENTIONAL Firmware, no digital voice
- 50 = Flash Revision Level #11
- M06 = radio contains a 081 control/logic board

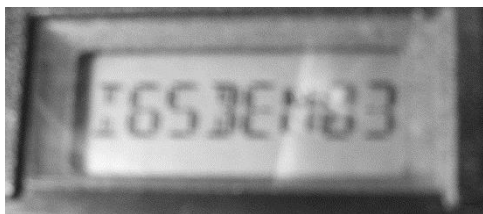
I65BEM03

- 65 = CONVENTIONAL Firmware with VG Digital & VGE encryption
- BE = REVISION GROUP #19
- M03 = radio contains a 081 control/logic board

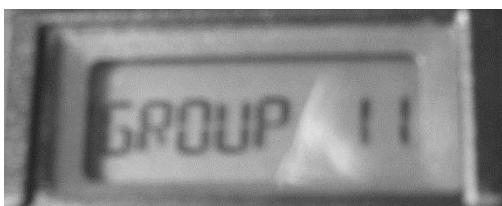
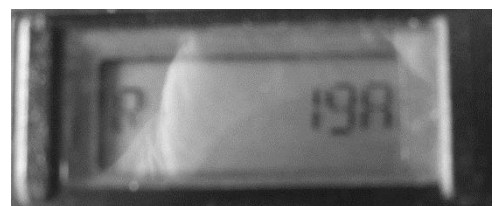
Group Levels usually say the word 'GROUP', however, the final release of firmware was Group 19, can display: '**GROUP 19**', '**R 19A**' or even '**ALPHA 19**' for some unknown reason. All are valid.

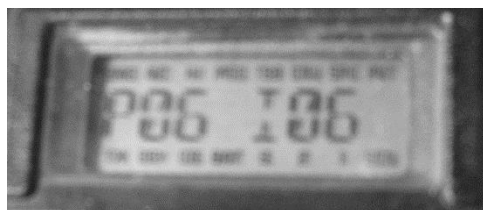
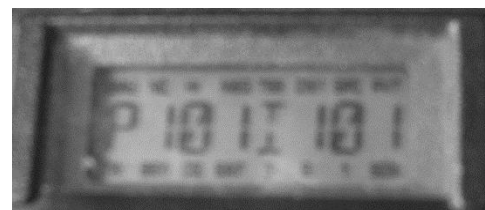
Firmware version display for HARDCODED RADIOS will always prefix with the letter "P":

While you cannot upgrade the firmware in a HARDCODED radio, *the radio is quite useable for conventional only operation*, and must be programmed using the DOS software application.

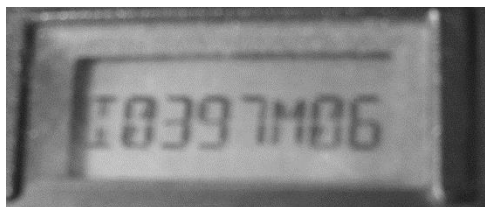
I0397M06

The both of the examples show below are for firmware released in March 1997.

0397 = HamFlash, Revision March 1997
M06 = radio contains a 081 control/logic board

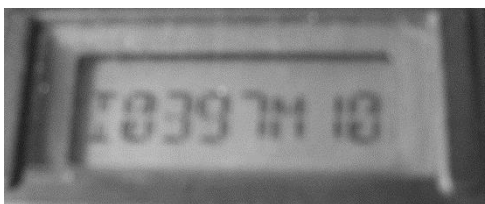
I0397M10

0397 = HamFlash, Revision March 1997
M10 = radio contains a 628 control/logic board
